Loudoun County Carbonate Area with Mapped Sinkholes - Route 15 Corridor

Map Number: 2007-015
Date Generated: February 6, 2007
Map Prepared By: Department of Building and Development, Loudoun County, VA

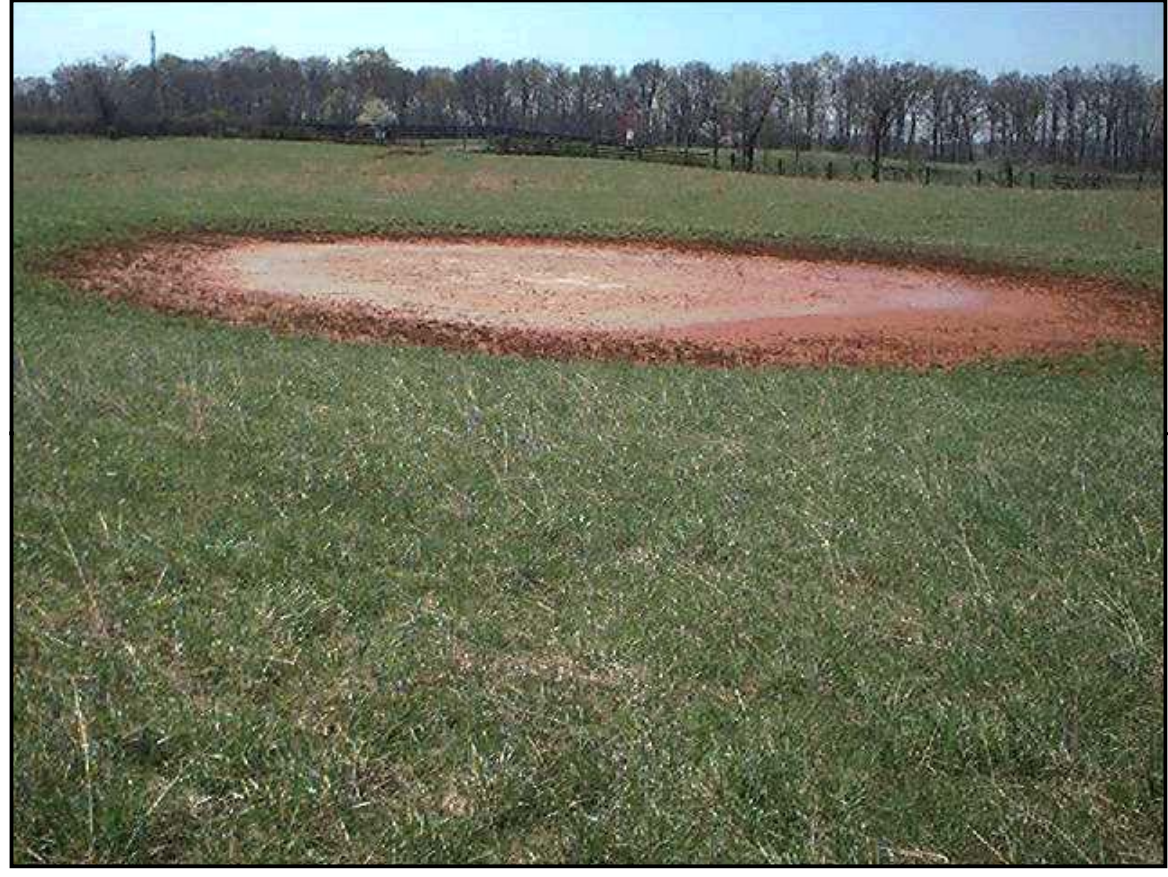
Selma Estates Subdivision (photograph date: April 14, 2003)
An old sinkhole that has formed a clay plug and collects water.

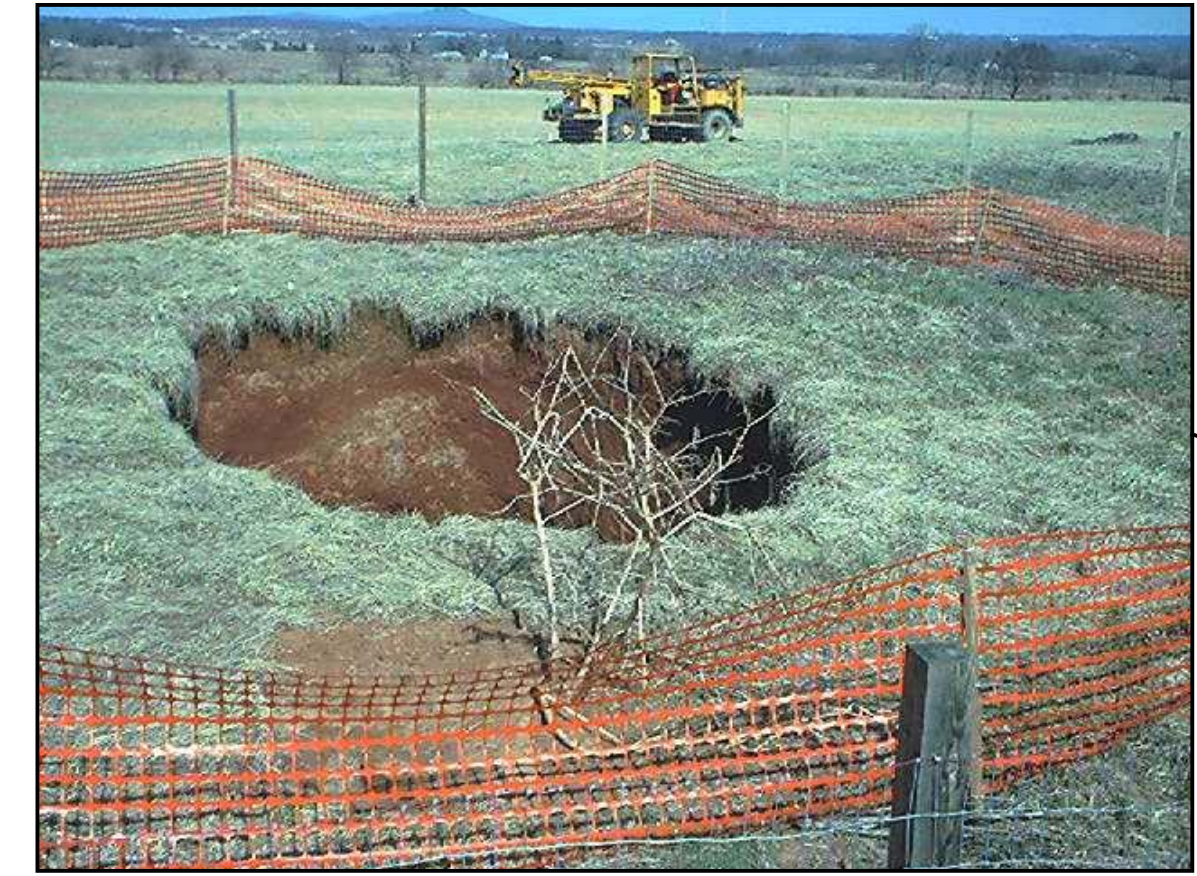
Selma Estates Subdivision (photograph date: March 27, 2003)
The sinkhole is approximately 30 feet in diameter and 30 feet in depth and opened approximately 100 feet from a well being installed.

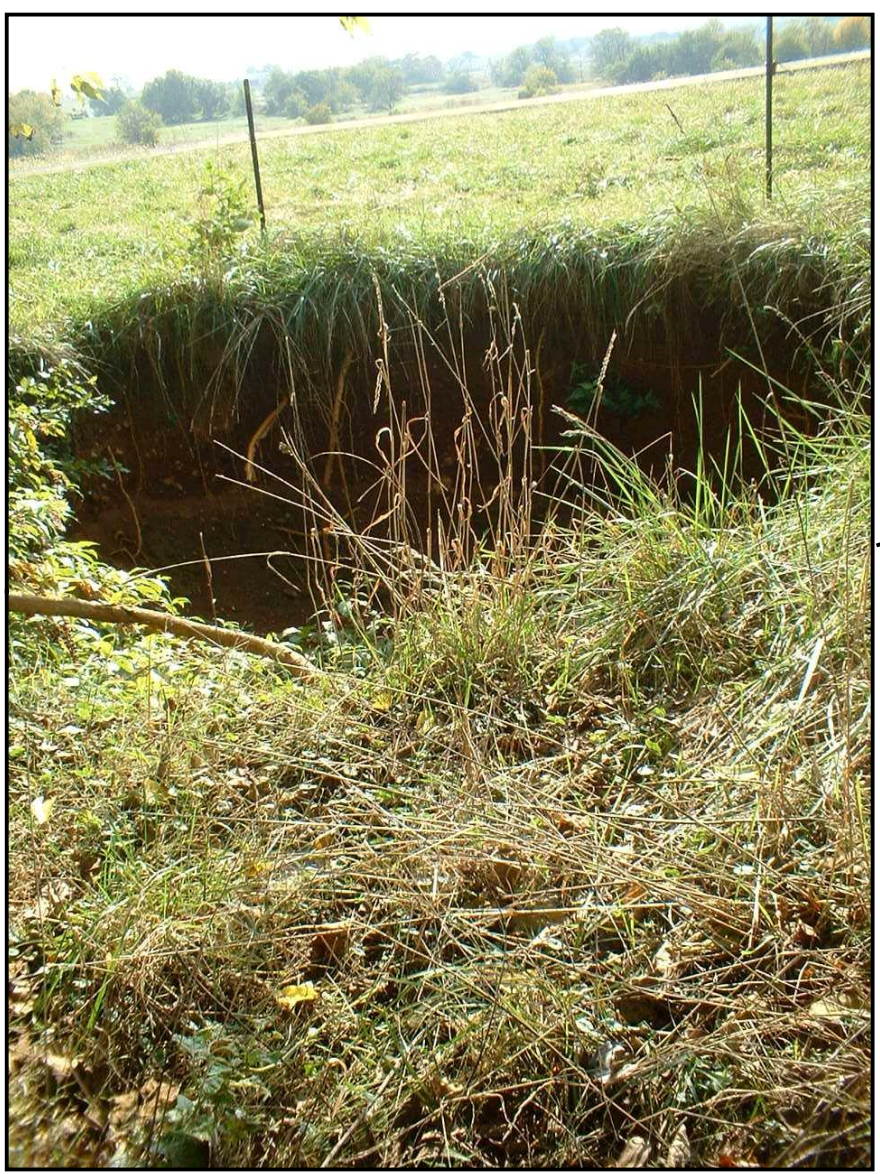
Raspberry Falls Subdivision
(photograph date: October 18, 2004)
The sinkhole is approximately 20 feet in diameter and 15 feet in depth.

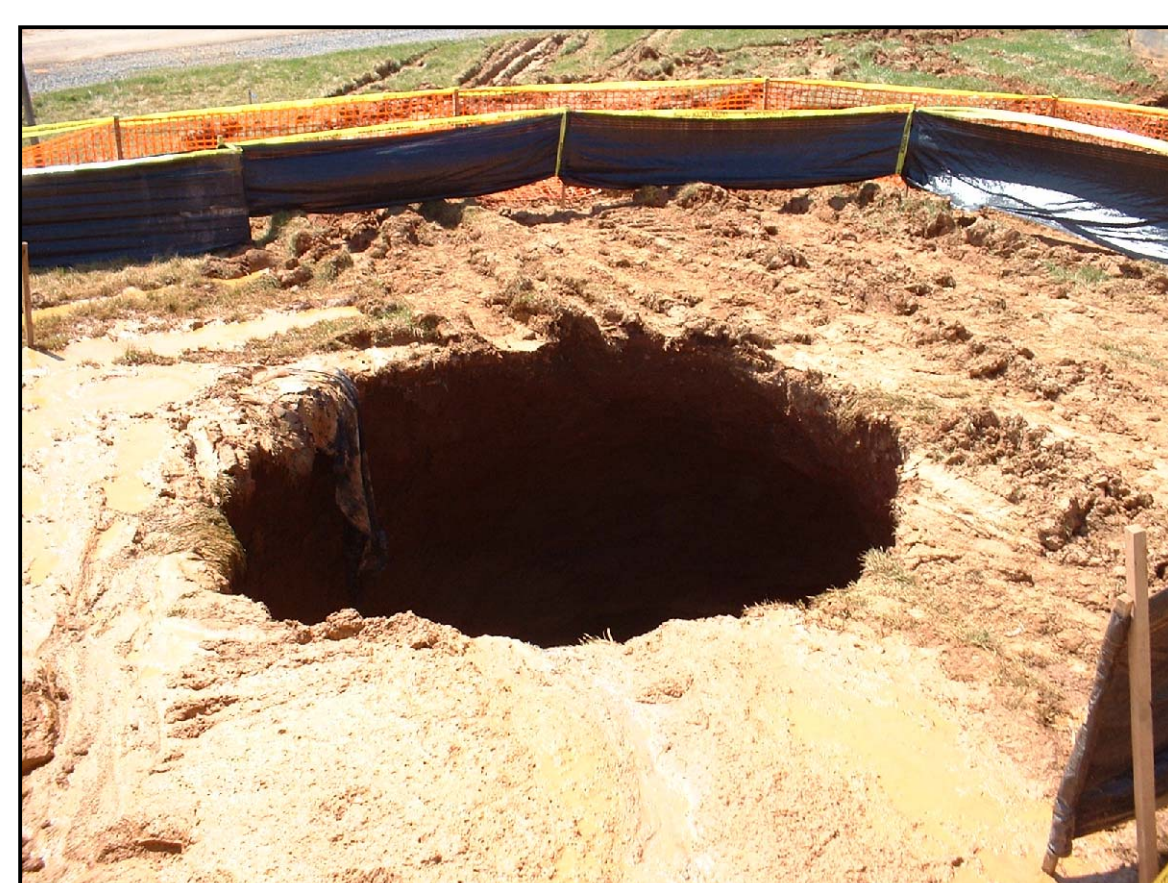
Leesburg Crossing Subdivision (photograph date: April 6, 2005)
The sinkhole is approximately 8 feet in diameter and opened during well installation.

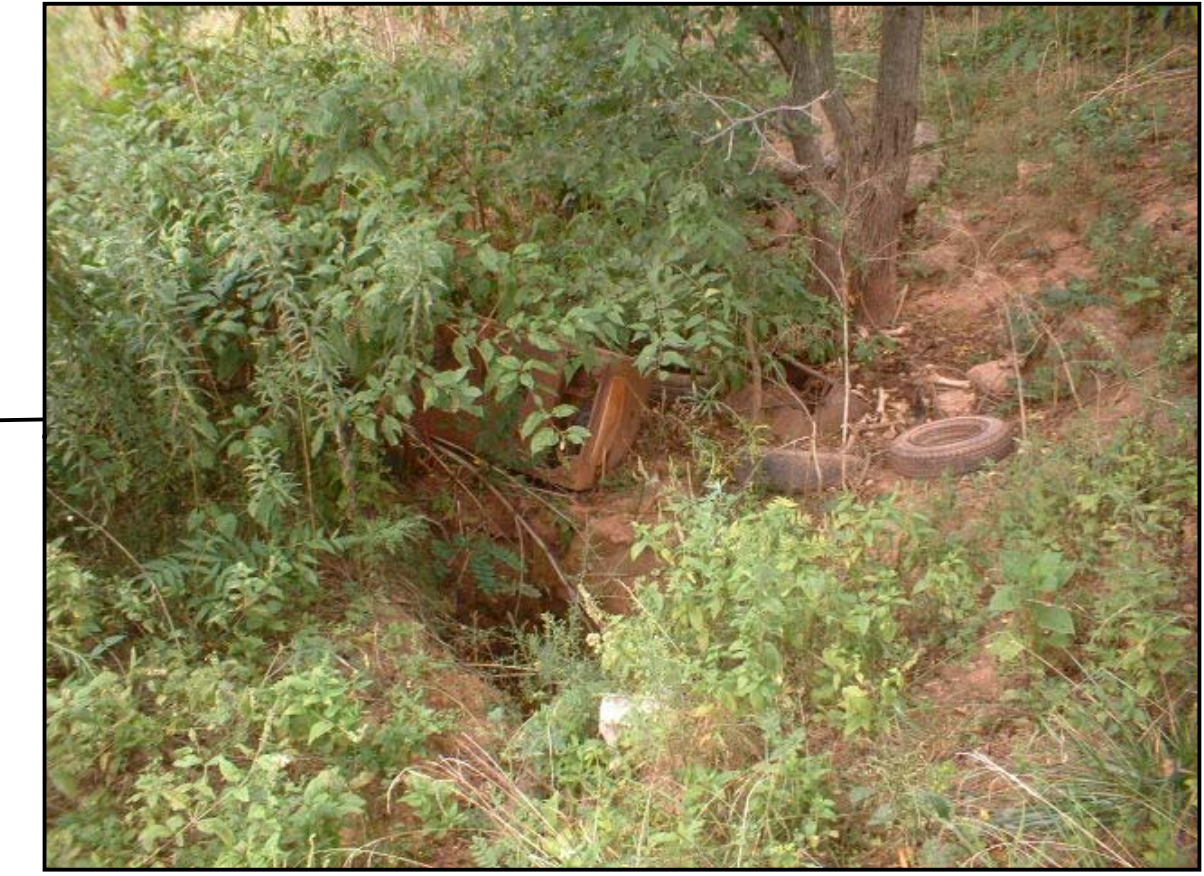
Zial Subdivision (photograph date: August 30, 2006)
Sinkhole with debris. Sinkholes have historically been used as a location for trash/debris collection.

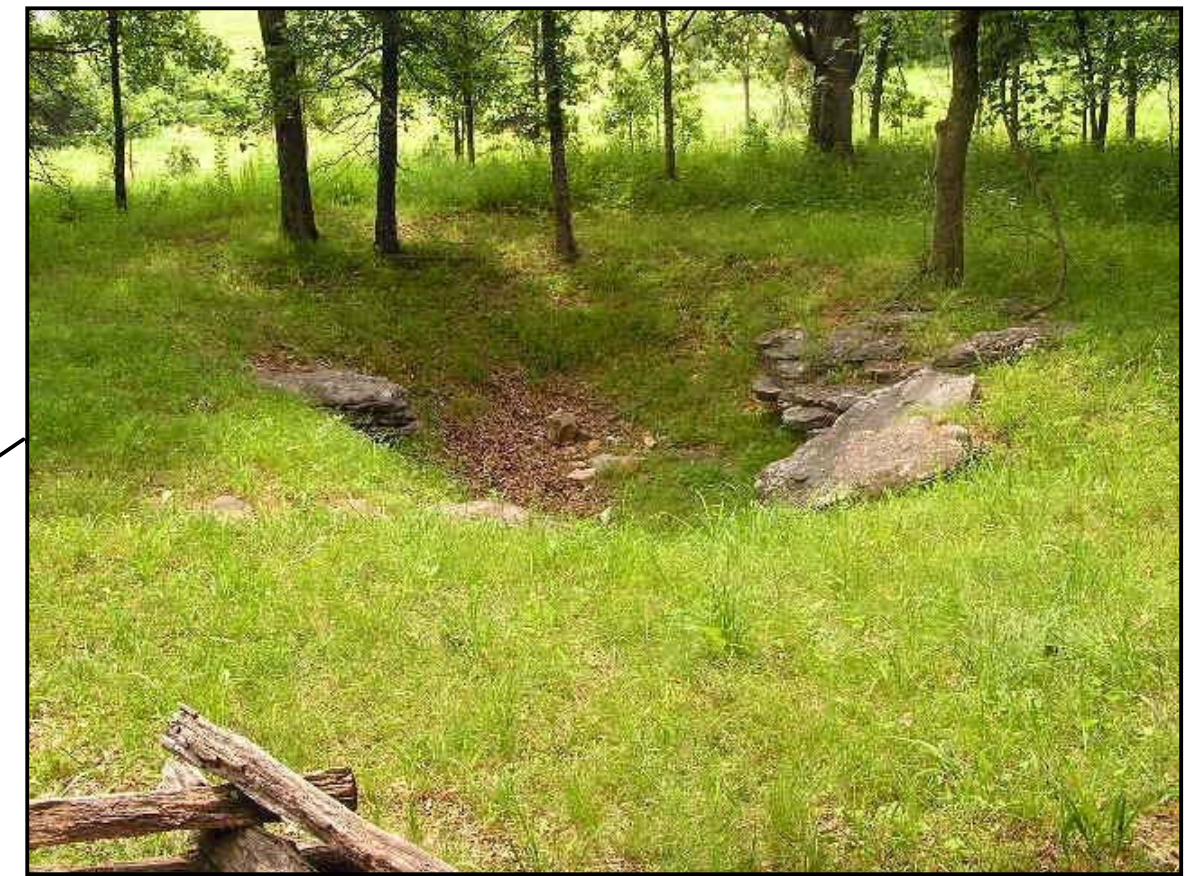
Morven Park
Older sinkhole beginning to healover.

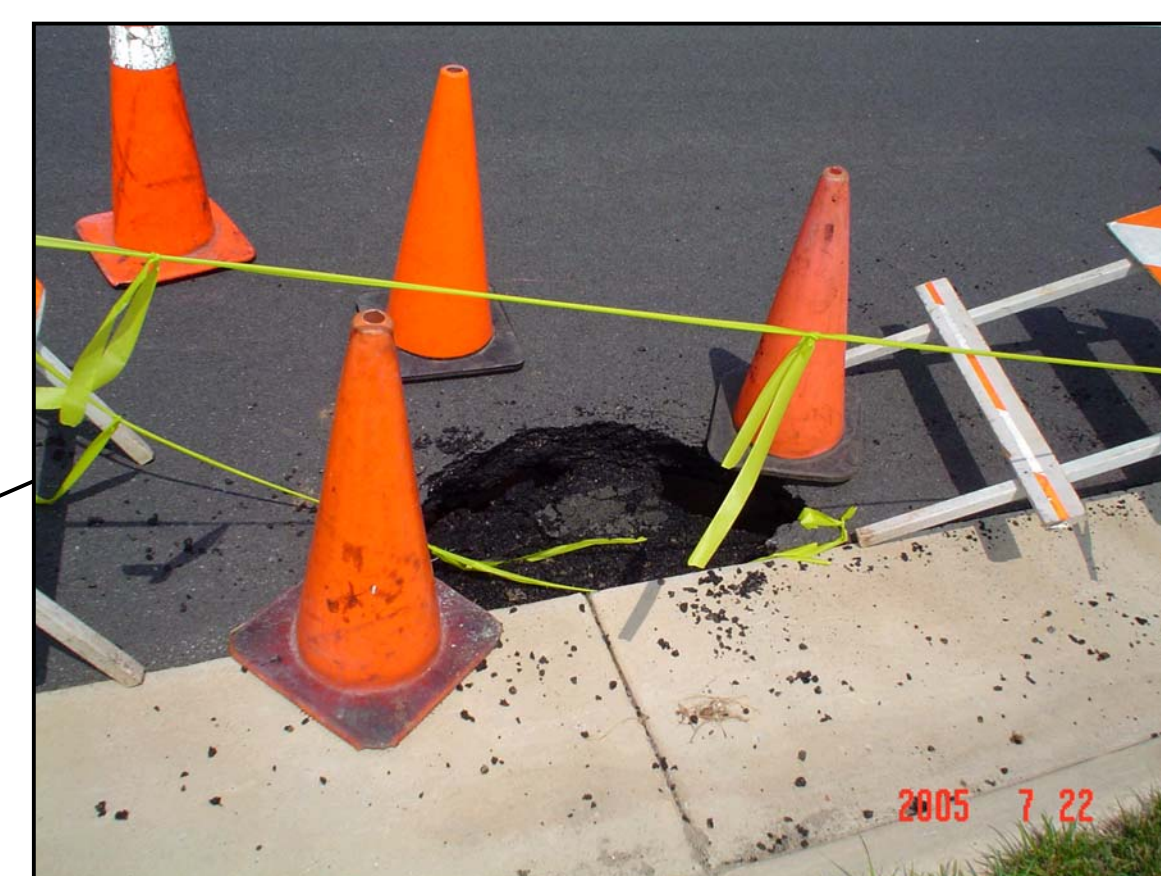
Route 15 Business near Dry Hollow Road (photograph date: July 22, 2005)
Sinkhole is approximately 3 feet in diameter and 6 to 8 feet in depth.

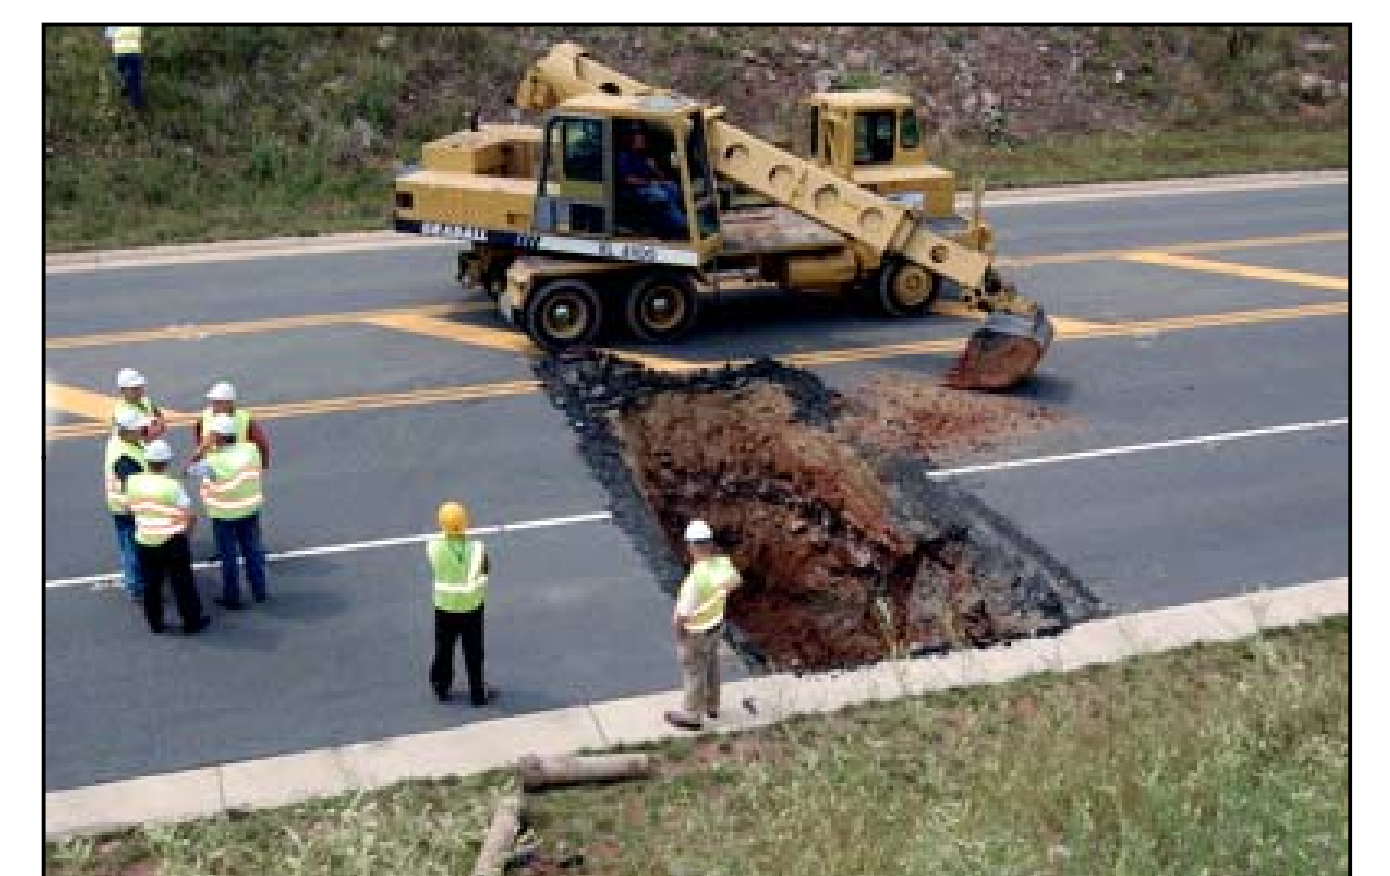
Approximately one year later, the sinkhole reopened at the same location. The sinkhole is approximately 20 feet in diameter and 15 to 18 feet in depth. (photograph date: June 28, 2006; source: Leesburg Today)

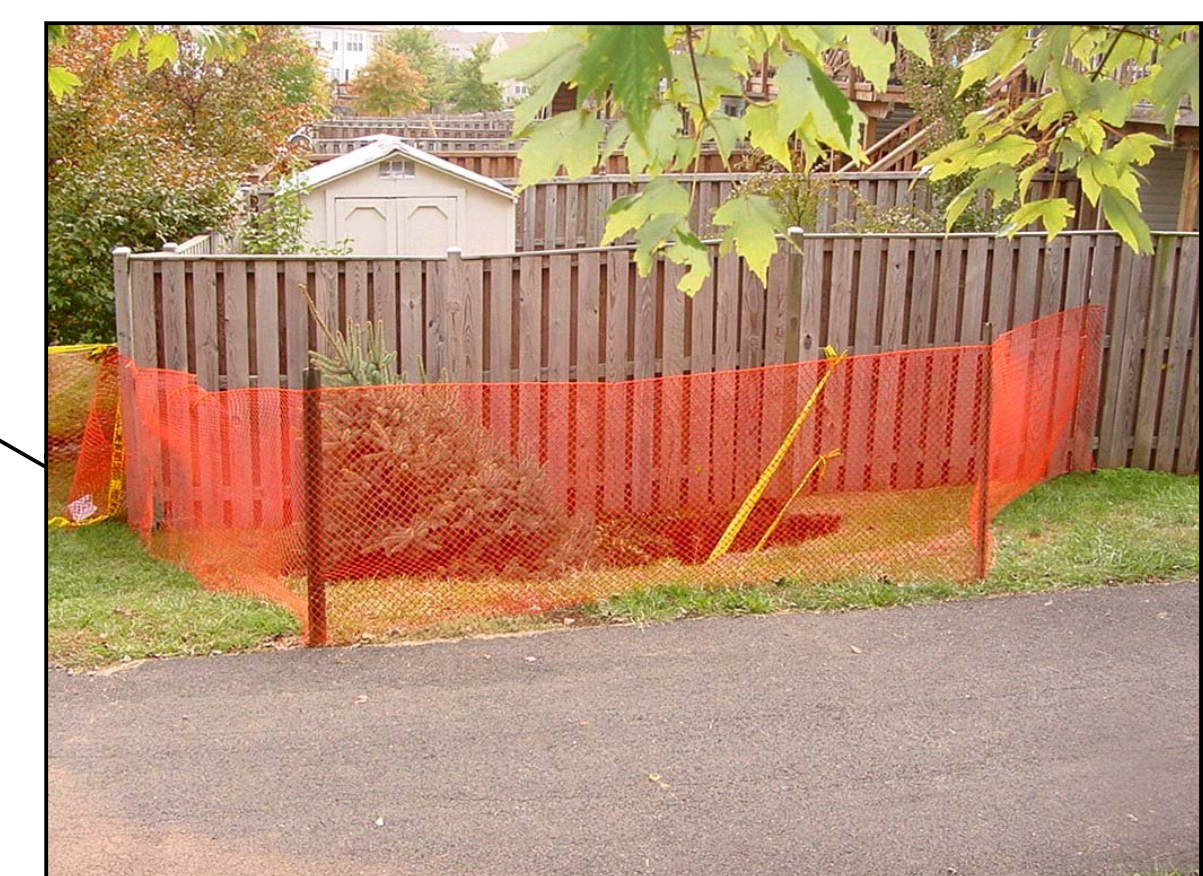
Exeter Subdivision (photograph date: January 10, 2002)
The sinkhole opened around a 24-foot spruce tree (6 feet exposed).
